**Flood Control Project Maintenance
Levee Inspections**

Fall 2013 Levee Maintenance Deficiency Summary Report

Reclamation District No. 0150 Merrit Island

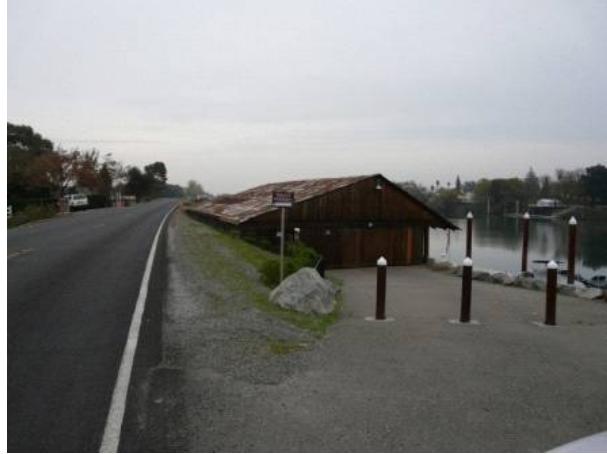
Levee Mile Report Line	3
Start Levee Mile	0.17
End Levee Mile	0.21
Location	Land Side
Category	Earthen Levee
Item	Vegetation
Landscaping was found on the landside of the levee looking upstream.	
pkazi_f_20131001_628.jpg

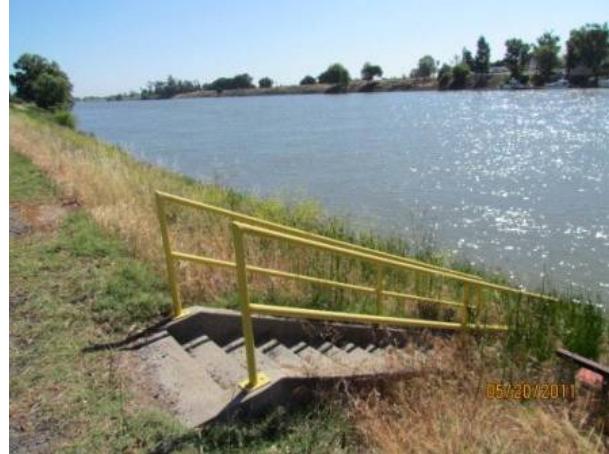
Levee Mile Report Line	15
Start Levee Mile	0.40
End Levee Mile	0.40
Location	Water Side
Category	Earthen Levee
Item	Slope Stability
Slope instability was found on the waterside of the levee looking upstream.	
pkazi_f_20131001_572.jpg

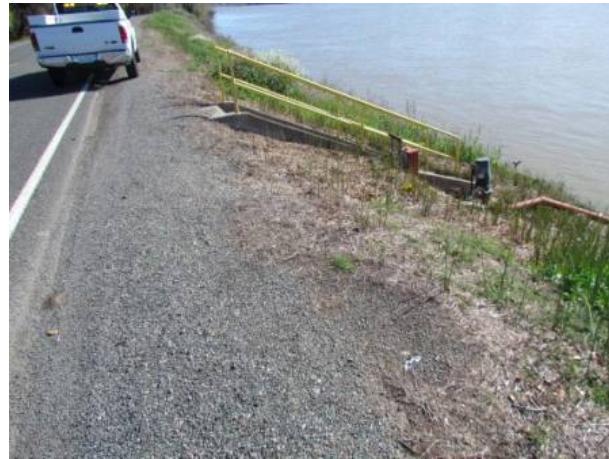
Levee Mile Report Line	17
Start Levee Mile	0.48
End Levee Mile	0.48
Location	Water Side
Category	Supplemental
Item	DWR UCIP Field Study
WS view: abandoned pump on levee slope. Dense vegetation on waterside.	
UCIP_12203.jpg

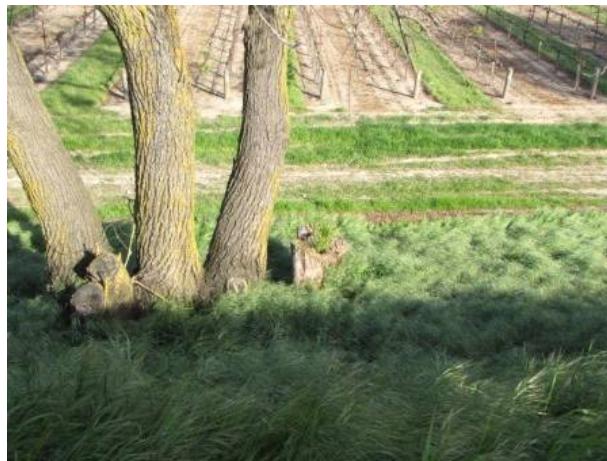
Levee Mile Report Line	25
Start Levee Mile	1.34
End Levee Mile	1.37
Location	Land Side
Category	Earthen Levee
Item	Vegetation
Landscaping was found landside of the levee looking upstream.	pkazi_f_20131001_614.jpg

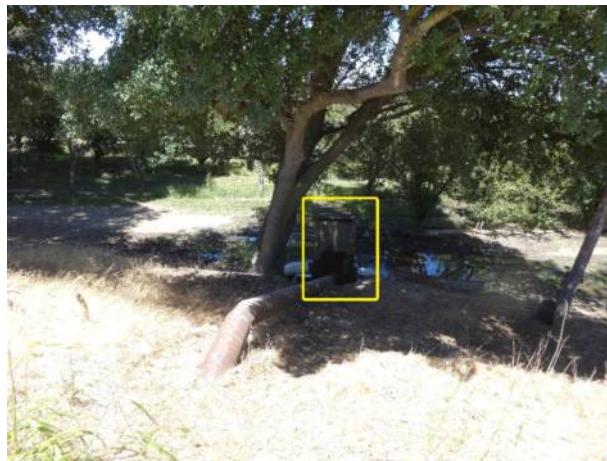
Levee Mile Report Line	28
Start Levee Mile	2.31
End Levee Mile	2.33
Location	Land Side
Category	Earthen Levee
Item	Vegetation
<p>Landscaping was found on the landside of the levee. The picture was taken from the crown looking upstream.</p> <p>pkazi_f_20131001_613.JPG</p>

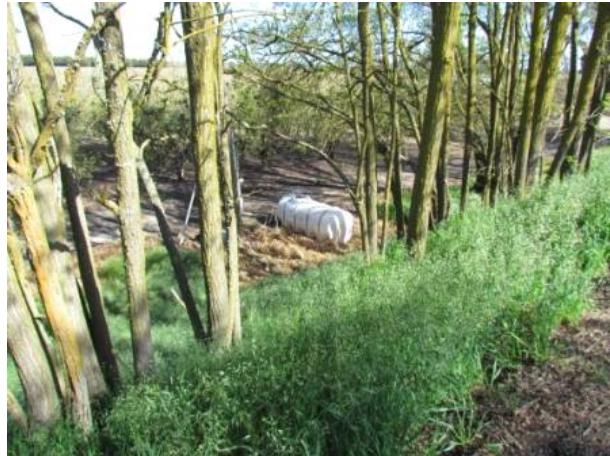
Levee Mile Report Line	30
Start Levee Mile	2.80
End Levee Mile	2.80
Location	Land Side
Category	Earthen Levee
Item	Trim / Thin Trees
View of a tree stump on the landward slope.	
pkazi_f_20131001_580.jpg

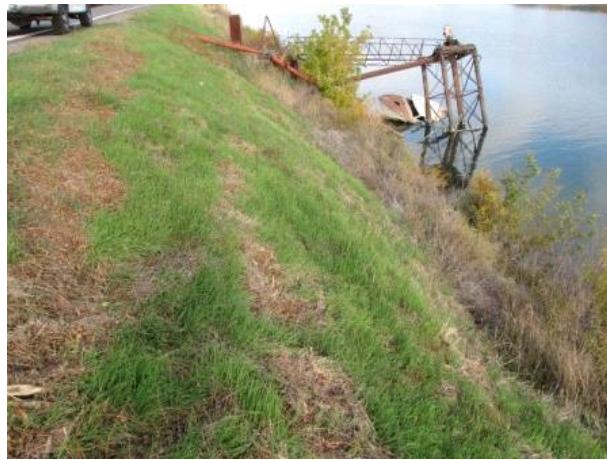
Levee Mile Report Line	33
Start Levee Mile	3.29
End Levee Mile	3.29
Location	Water Side
Category	Earthen Levee
Item	Erosion / Bank Caving
Additional view of erosion on the waterward slope looking upstream. Note the damaged pump support, pump, and pipe just upstream of the site.	
pkazi_f_20131001_620.jpg

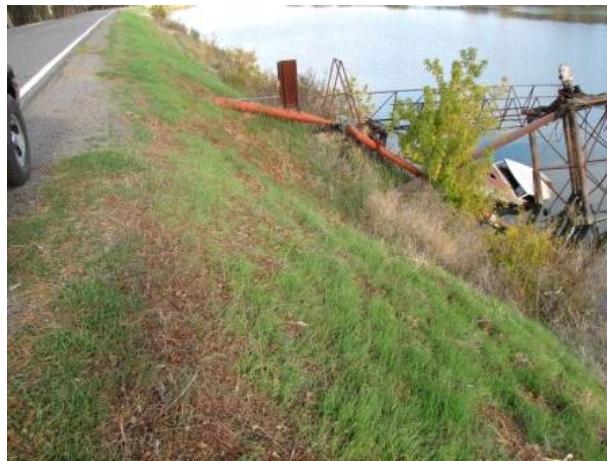
Levee Mile Report Line	33
Start Levee Mile	3.29
End Levee Mile	3.29
Location	Water Side
Category	Earthen Levee
Item	Erosion / Bank Caving
View of the erosion site, and broken pump support along with a boat on the waterside of the levee. The picture was taken from the crown looking towards the toe of the levee during fall 2011 inspection.	
pkazi_f_20131001_621.jpg

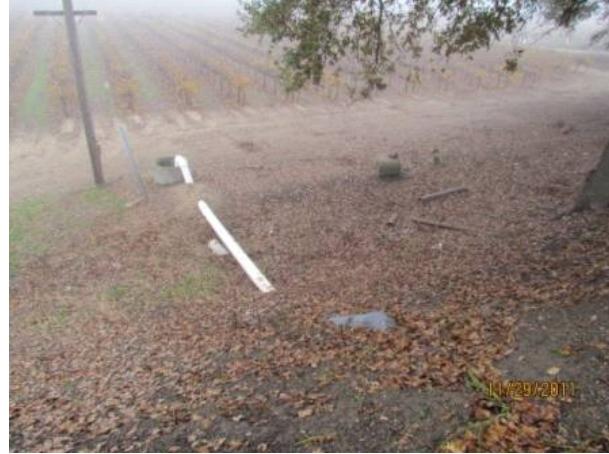
Levee Mile Report Line	35
Start Levee Mile	3.56
End Levee Mile	3.56
Location	Crown
Category	Earthen Levee
Item	Encroachments
A PVC pipe was used to pump the water from waterside of the levee. It appeared that the PVC pipe was penetrating through a corroded steel casing through the levee crown. The picture was taken from the crown of the levee looking upstream during spring 2013 inspection.	
pkazi_f_20131001_582.JPG

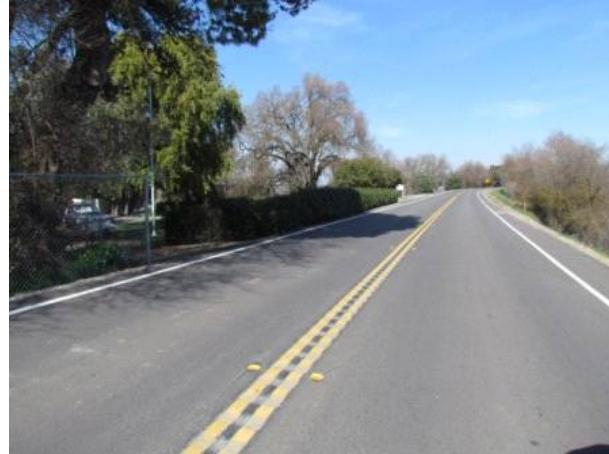
Levee Mile Report Line	51
Start Levee Mile	5.17
End Levee Mile	5.22
Location	Land Side
Category	Earthen Levee
Item	Vegetation
View of landscaping along the landward shoulder and slope looking downstream.	
pkazi_f_20131001_607.jpg

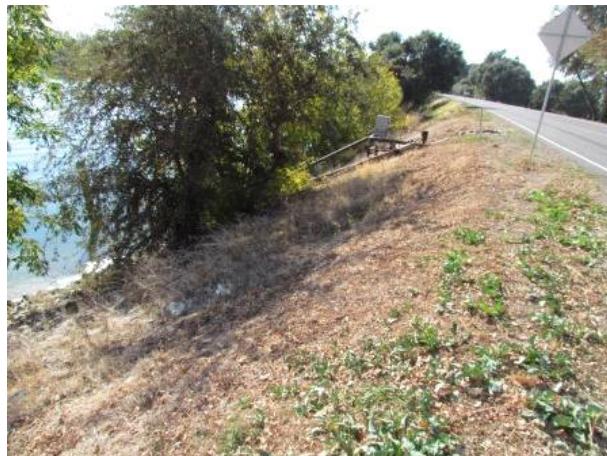
Levee Mile Report Line	56
Start Levee Mile	6.41
End Levee Mile	6.41
Location	Land Side
Category	Earthen Levee
Item	Vegetation
Century plant was found on the landside of the levee looking upstream.	
pkazi_f_20131001_589.jpg

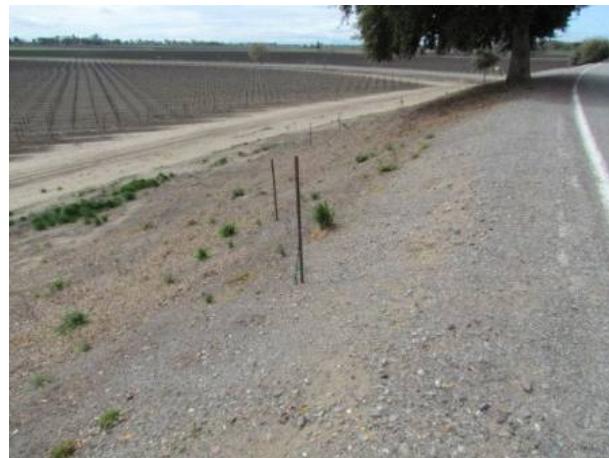
Levee Mile Report Line	21
Start Levee Mile	2.34
End Levee Mile	2.34
Location	Land Side
Category	Earthen Levee
Item	Encroachments
New tree was found on the landside shoulder of the levee looking downstream. This picture was taken during fall 2012 inspection.	
pkazi_f_20131001_704.jpg

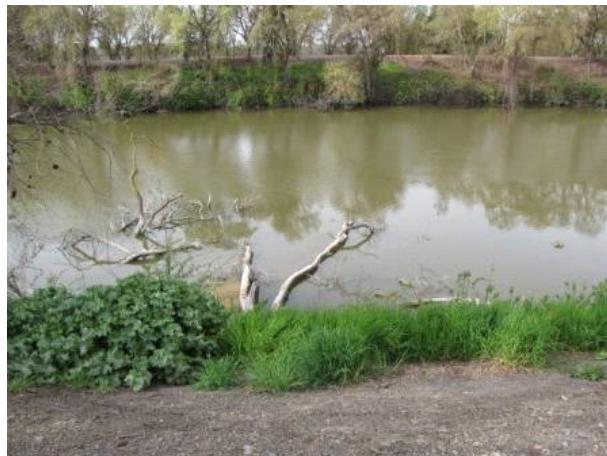
Levee Mile Report Line	26
Start Levee Mile	2.93
End Levee Mile	2.93
Location	Water Side
Category	Earthen Levee
Item	Slope Stability
Slope instability was found on the waterside of the levee. The picture was taken from the crown looking towards the toe of the levee.	
pkazi_f_20131001_699.jpg

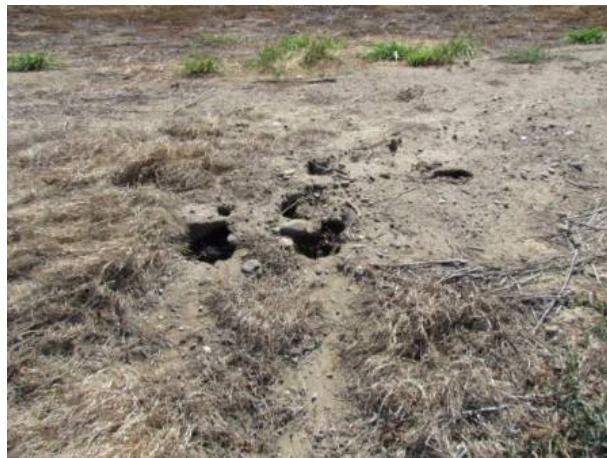
Levee Mile Report Line	32
Start Levee Mile	3.34
End Levee Mile	3.34
Location	Land Side
Category	Earthen Levee
Item	Encroachments
Material was found on the landside of the levee looking downstream.	
pkazi_f_20131001_695.jpg

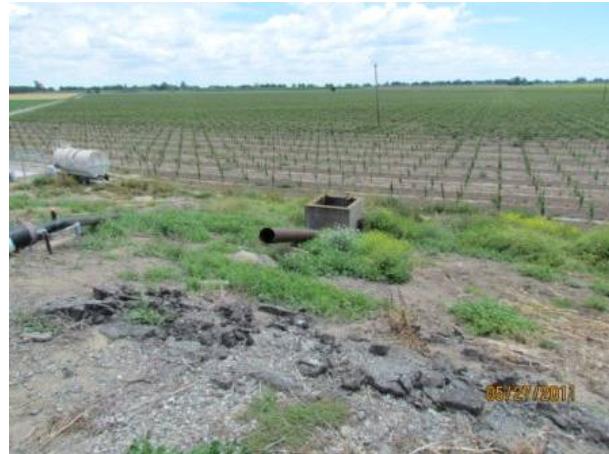
Levee Mile Report Line	35
Start Levee Mile	3.37
End Levee Mile	3.37
Location	Water Side
Category	Earthen Levee
Item	Erosion / Bank Caving
Erosion was found on the waterside toe of the levee looking upstream during spring 2013 inspection.	
pkazi_f_20131001_659.JPG

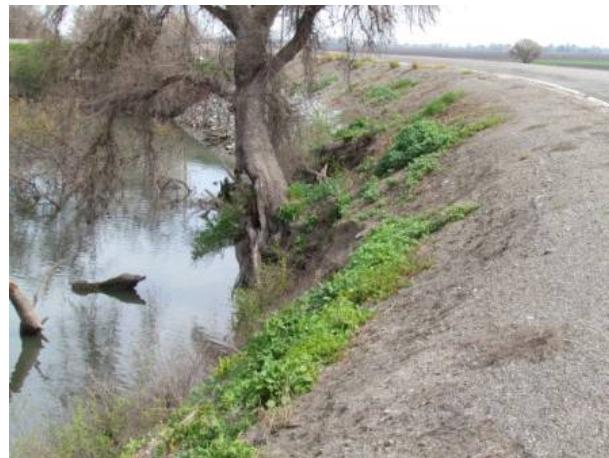
Levee Mile Report Line	36
Start Levee Mile	3.41
End Levee Mile	3.41
Location	Water Side
Category	Earthen Levee
Item	Trim / Thin Trees
View of tree stumps on the waterside slope looking upstream.	
pkazi_f_20131001_646.jpg

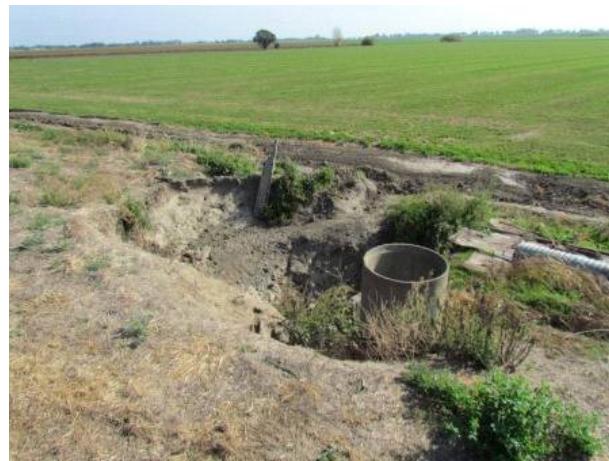
Levee Mile Report Line	39
Start Levee Mile	3.47
End Levee Mile	3.47
Location	Water Side
Category	Earthen Levee
Item	Erosion / Bank Caving
Erosion was found on the waterside of the levee looking downstream.	
pkazi_f_20131001_718.jpg

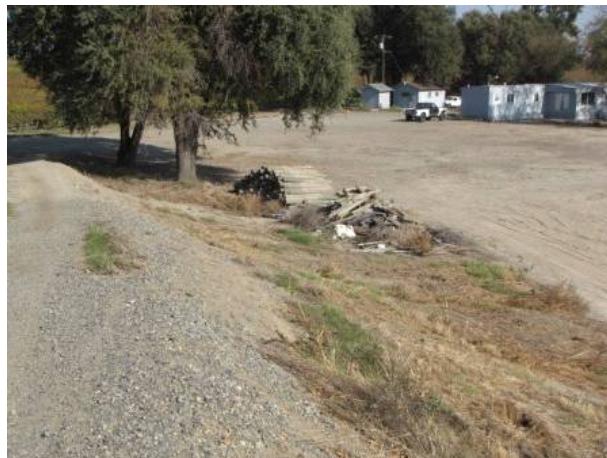
Levee Mile Report Line	49
Start Levee Mile	3.95
End Levee Mile	3.95
Location	Land Side
Category	Earthen Levee
Item	Encroachments
Debris found on the landside of the levee during Spring 2011 inspection. The picture was taken from the crown looking upstream.	
pkazi_f_20131001_667.jpg

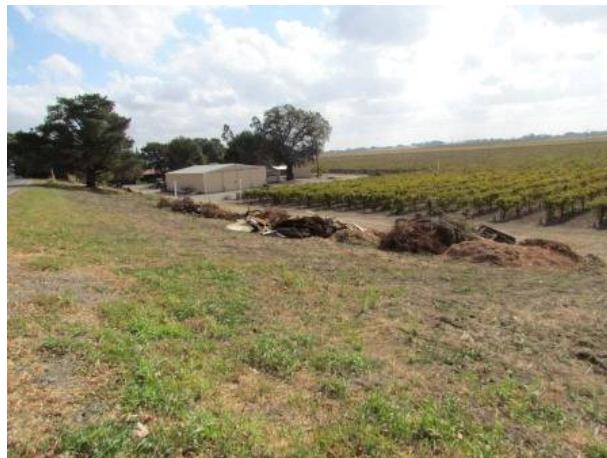
Levee Mile Report Line	52
Start Levee Mile	4.51
End Levee Mile	4.51
Location	Land Side
Category	Earthen Levee
Item	Encroachments
Tree branches were found on the toe of landside of the levee. The picture was taken from the crown looking downstream.	
pkazi_f_20131001_673.jpg

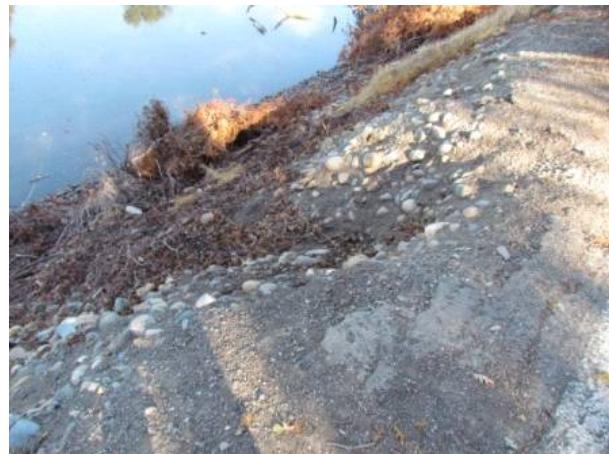
Levee Mile Report Line	59
Start Levee Mile	5.13
End Levee Mile	5.13
Location	Water Side
Category	Earthen Levee
Item	Slope Stability
Slope instability was found on the waterside of the levee looking upstream.	
pkazi_f_20131001_630.jpg

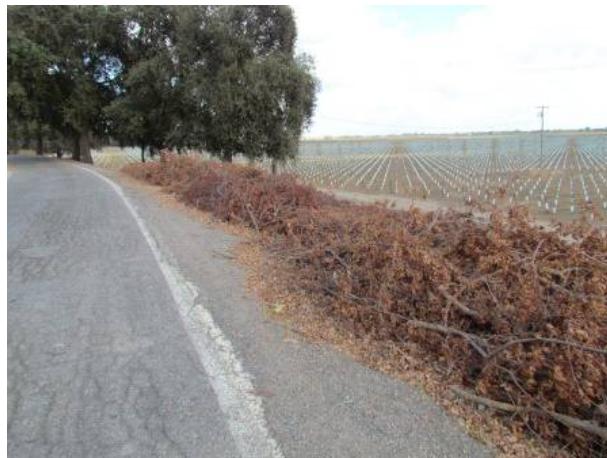
Levee Mile Report Line	61
Start Levee Mile	5.22
End Levee Mile	5.22
Location	Crown
Category	Earthen Levee
Item	Crown Surface / Depressions / Rutting
View of varying elevations in the crown of the levee at the transition from county road to access road.	
pkazi_f_20131001_728.jpg

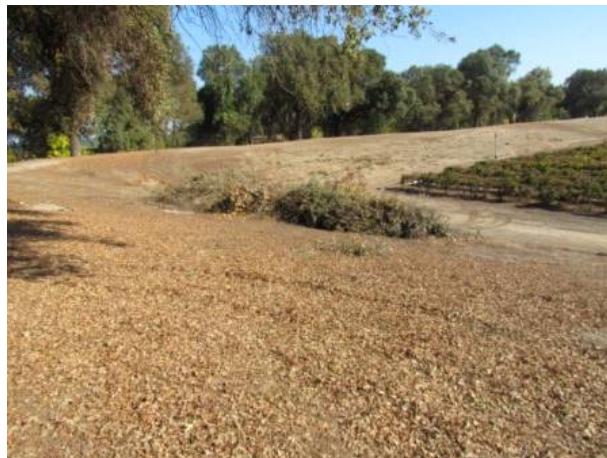
Levee Mile Report Line	62
Start Levee Mile	5.61
End Levee Mile	5.61
Location	Land Side
Category	Earthen Levee
Item	Encroachments
Updated picture of debris and pruning on the landside toe of the levee looking upstream. This picture was taken during spring 2013 inspection.	
pkazi_f_20131001_637.JPG

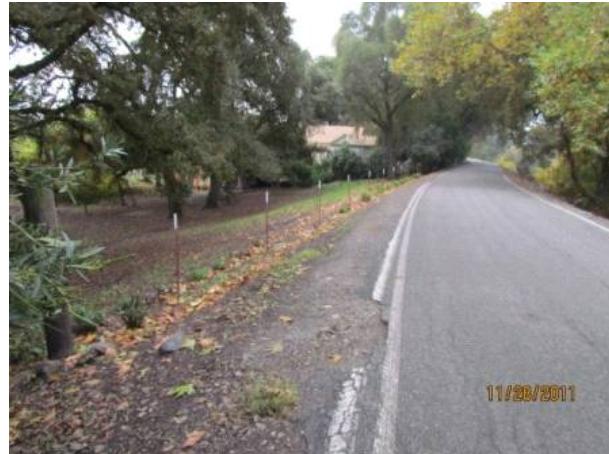
Levee Mile Report Line	87
Start Levee Mile	6.98
End Levee Mile	7.04
Location	Land Side
Category	Earthen Levee
Item	Vegetation
View of the landscape on the landside shoulder of the levee looking downstream.	pkazi_f_20131001_721.JPG

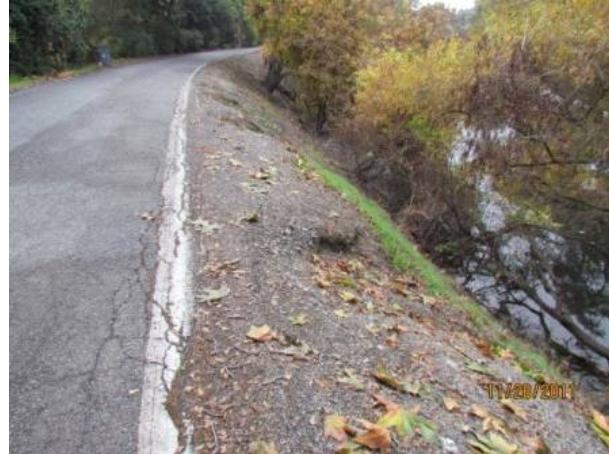
Levee Mile Report Line	89
Start Levee Mile	7.02
End Levee Mile	7.02
Location	Water Side
Category	Earthen Levee
Item	Erosion / Bank Caving
Erosion on the waterside of the levee looking upstream. This picture was taken during spring 2012 inspection.	
pkazi_f_20131001_682.jpg

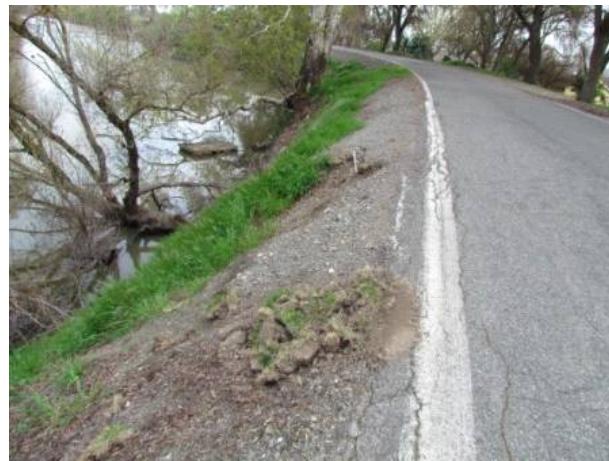
Levee Mile Report Line	89
Start Levee Mile	7.02
End Levee Mile	7.02
Location	Water Side
Category	Earthen Levee
Item	Erosion / Bank Caving
Erosion was found on the waterside slope of the levee looking downstream. This updated picture was taken during fall 2012 inspection.	
pkazi_f_20131001_683.jpg

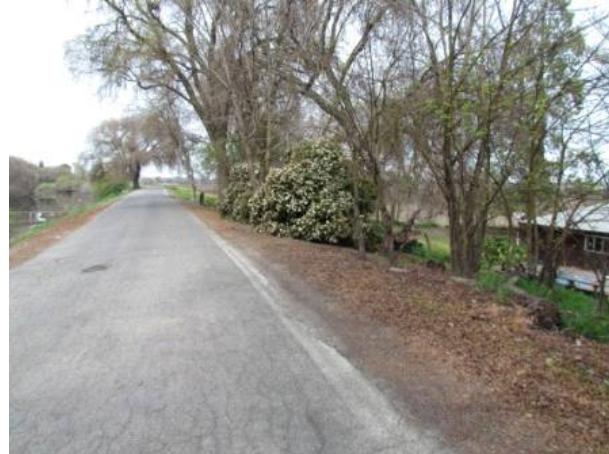
Levee Mile Report Line	91
Start Levee Mile	7.34
End Levee Mile	7.34
Location	Land Side
Category	Supplemental
Item	DWR UCIP Field Study
WS view: 8-inch pipe and pump on levee slope (right)	
UCIP_12141.jpg
